Manhole Inspection Summary

Manhole # S05SS1021MH

Insp Date: **10/2/06 10:34 AM**

Location Address: **3401 INGLESIDE AVE**

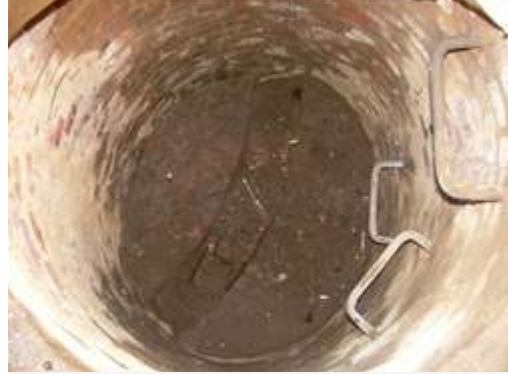
Top View

Evidence of surcharge - Bench debris.
Channel debris.

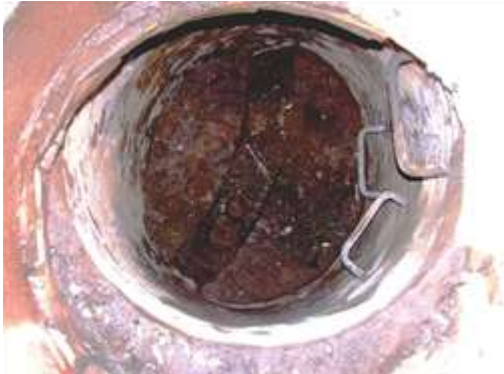
Defect

Comments **The Frame and the Adjustment are offset. Unable to obtain the O12 invert measurments due to heavy debris.**

Frame offset. Frame leaks. Adjustment deterioration and infiltration. Barrel infiltration.

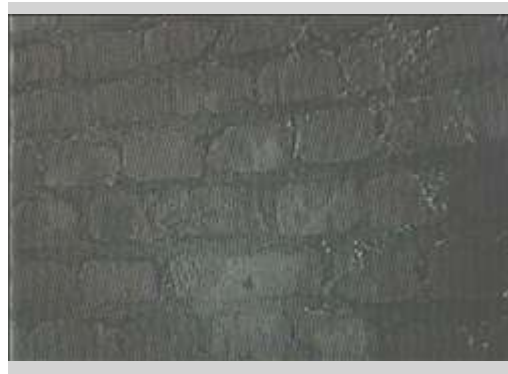
Defect

Barrel deterioration and infiltration.

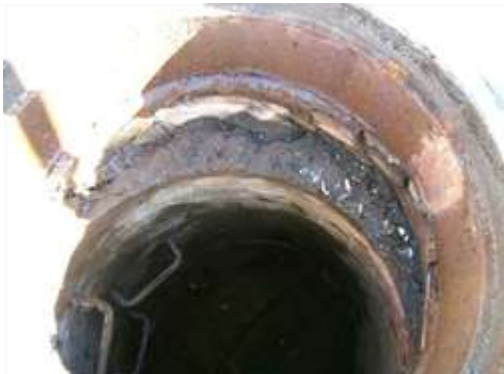
Defect

Frame leaks. Frame offset. Adjustment deterioration and infiltration.

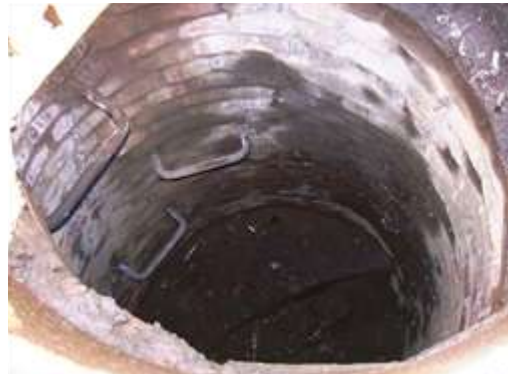
Defect

Adjustment, Corbel and Barrel infiltration.

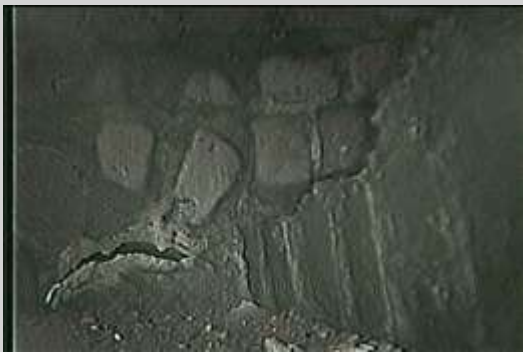
8 in. Circular Gravity Sewer Pipe Out @ 12 O'Clock

Deposits: ☐ None ☒ **Mud** ☐ Sludge ☒ **Debris** ☐ Grease

Silt Depth: **5** (in.) Deposits Extent: **Heavy**
